# GROUND IMPROVEMENT OF CONTAMINATED UNCONTROLLED FILL USING IMPACT ROLLER COMPACTION

Q J Yang<sup>1</sup>, A Succar<sup>1</sup>, J McIlquham<sup>2</sup> and K Chen<sup>2</sup>

<sup>1</sup>Arcadis Pacific Australia Pty Ltd, Sydney, Australia; <sup>2</sup>Golder Associates Pty Ltd, Sydney, Australia

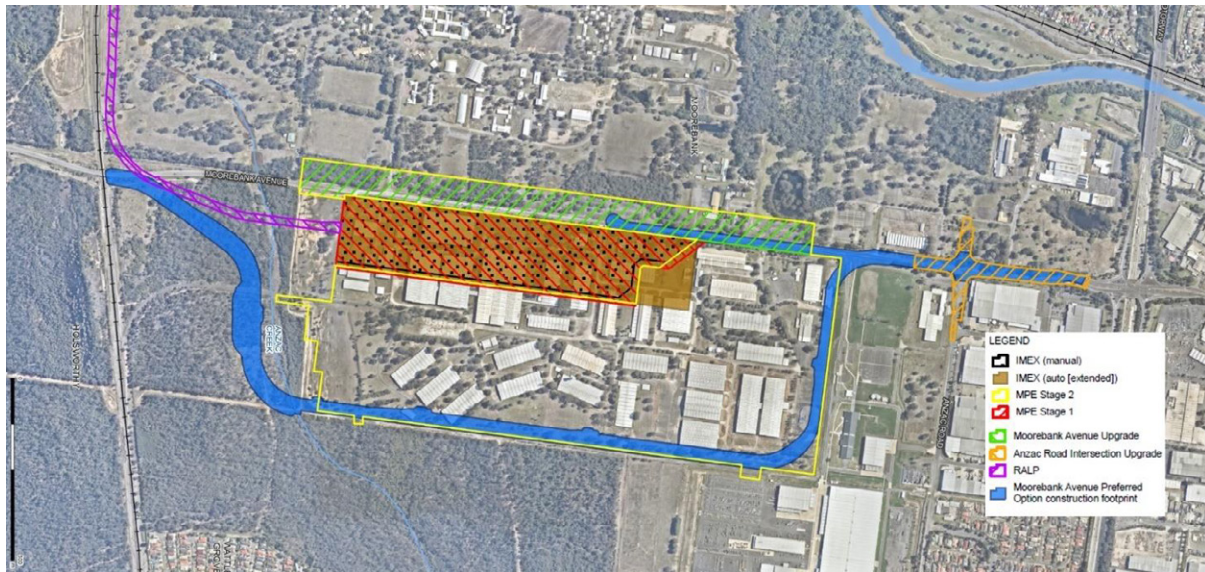
**Figure 1: Terminal Footprint (image © Google Maps)**

The site is located approximately 28 km to the south west of Sydney. The site was previously occupied by the Defence National Storage and Distribution Centre (DNSDC), and comprised multistorey buildings, large storage warehouses, roads, pavement areas, outdoor sitting areas, grassed areas, and a refuelling depot. The Stage 1 Proposal is located to the east of Moorebank Avenue and is an approximately rectangular parcel of land, about 400 m wide (east to west) and 850 m long (north to south). The Proposal also includes a rail link, approximately 3.5 km long, connecting the site to the Southern Sydney Freight Line (SSFL). The Stage 1 site and rail corridor footprint are presented in Figure 1.

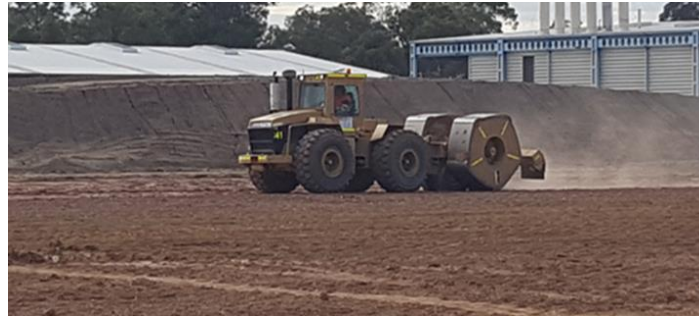
**Figure 3: Tractor and pentagonal drum used**

After the trial of varying number of passes using IRC, it was found that 15 passes using a 3 m wide, 15 tonne, pentagonal dynamic compaction drum towed by a 4 wheeled tractor, as shown in Figure 3, was the best IRC treatment method for the subject site. This drum operates with a drop height of 150 mm to provide 22 kJ of energy during impact rolling (Landpac, 2015). Dynamic response of the ground to the roller was monitored continuously via the Continuous Impact Response (CIR) system, which generated a “coloured map” identifying the level of soil response after the different number of passes. CIR has been adopted by others to verify IRC treatment, as discussed by Kelly and Gil (2012), and further details relating to CIR technology are presented by Landpac (2017). Following the IRC treatment, the surface was smoothed using a smooth drum roller and a “post-IRC” proof roll was also carried out to identify potential areas of concern which were initially identified using the CIR system. Deflected areas which were observed during the post-IRC proof roll generally corresponded to areas which registered low or very low responses on the CIR plots (represented by yellow and red shading in Figures 5(a) and 5(b)) which typically were related to former service trenches or low lying areas, where there was a tendency for water to pond. These areas could not be improved by IRC and were remediated using conventional methods of removal and replacement of compacted fill, as shown in Figure 4.

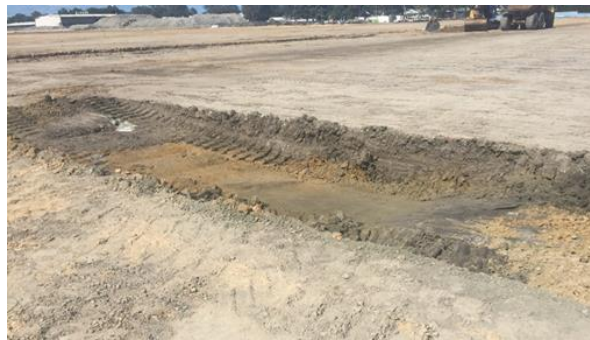
**Figure 4: Removal and replace of areas post proof rolling**
